# Fire and Explosions at Chiba Refinery

## Accident Summary

## Accident Causes and Future Preventative Measures

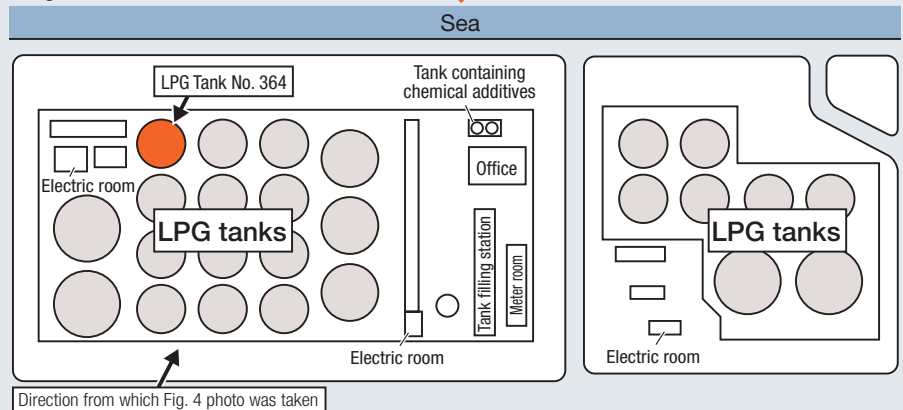
■ Figure 2. LPG tank site

- ◎ The quake caused the fracture of many cross-braces on the support legs of LPG Tank No. 364 (Fig. 2 and 3), which at the time was not full of LPG, but water used to purge air from the tank for a regulatory overhaul inspection.

Refer to Fig. 2 for the location of the fire in relation to the site.

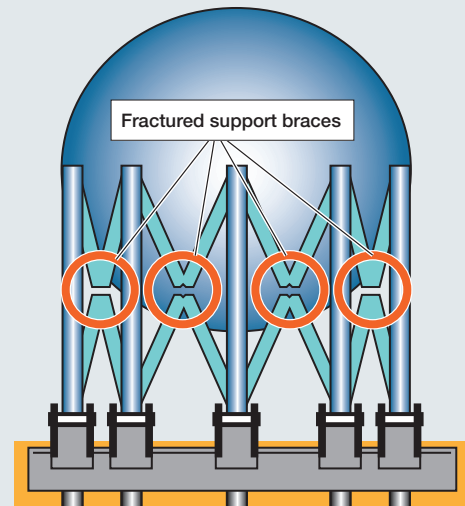
■ Figure 3. Fractured support braces of LPG Tank No. 364

- ◎ At 3:15 p.m., another earthquake occurred off the coast of Ibaraki Prefecture. The quake registered a four in seismic intensity in Ichihara City.
- ◎ The second quake buckled the support legs (with fractured cross-braces) of LPG Tank No. 364, which caused the tank to collapse. This led to the rupture of multiple pipes near the tank, and the leakage of LPG.

LPG Tank No. 364 was designed and built to seismic standards. At the time of the accident, the tank was full of water, which weighs twice as much as LPG, in preparation for regulatory overhaul inspections. The initial quake, combined with the added weight, caused the support cross-braces to fracture, and the subsequent quake caused the support legs to buckle and the tank to collapse. Better recognition was needed of the potential risk from an earthquake occurring when a tank was filled with water.

From now on, the Company will shorten the period during which the tanks are filled to capacity with water. Future LPG tanks will be designed specifically to hold a full tank of water, and existing LPG tanks will be evaluated and reinforced. To address the possibility of a tank collapsing, thereby damaging nearby pipelines and equipment, the Company will modify its facilities to protect pipelines and equipment, and enable the isolation and separation of pipelines as safeguards against LPG leakage.

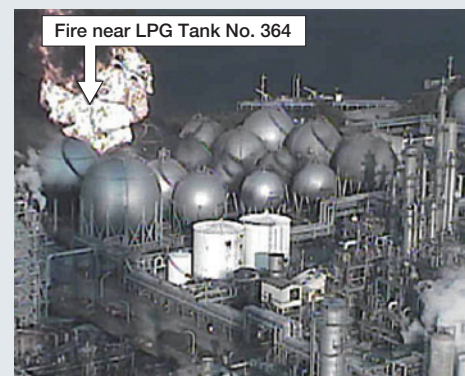
■ Figure 4. Ignition of leaking LPG and fire

- ◎ The leaking LPG spread and caught fire, leading to a fire near LPG Tank No. 364 (Fig. 4).
- ◎ The fire caused an adjacent LPG tank to explode, as the fire spread.

The investigation was unable to determine the exact cause of ignition. After the fire broke out, fire crews continuously sprayed water on the surrounding LPG tanks to keep them cool, but the fire near LPG Tank No. 364 grew in intensity, which raised the surface temperature of the adjacent LPG tanks. This weakened the tanks, to the extent that they could not contain their internal pressure, and the resulting explosions caused the fire to spread.

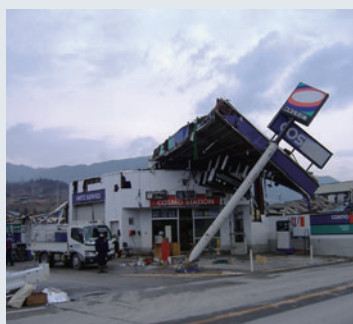
Service station damaged due to March 11 quake (taken on March 25, 2011)
